GOOD2KNOW – 06/10/2015
Process instructions

Good2know that... personal hygiene or clothing can affect the result of your powder coated material.

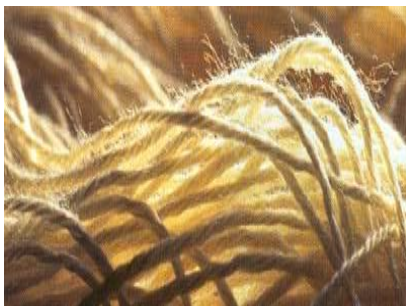
In some cases, defaults in powder coating are created due to the clothing or make-up habits of your staff. As there was the case, for instance, of coating craters that were caused by hair wax. While at first sight there was no clear cause for the poor coating result, after evaluation of the process it appeared that the wax the workers were using in their hair and regularly got back in contact with because of remodeling their hair during production process, was transferred onto the metal substrates they picked up with their (waxy) hands to hang up for coating. Hair wax can contain silicon oil, which

proves to be very difficult to remove. As a result, the powder no longer sticks to the soiled zones of the substrate.

As much as pretreatment of your material is required, as important is keeping up with the correct clothing instructions during the powder coating process. Make sure that your crew wears the fit production clothing and understands the process prescriptions.
